Manhole Inspection Summary

Manhole # S33E__035MH

Insp Date: 11/11/08 2:05 PM

Location Address: **14 w saratoga st**

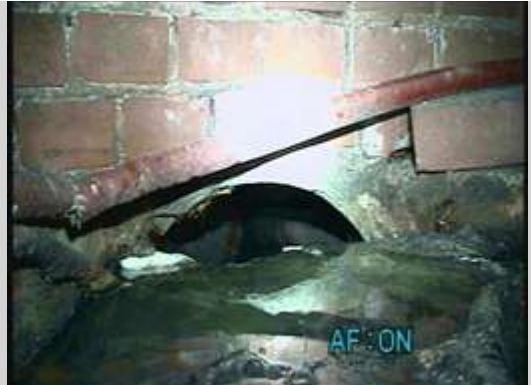
12 O'Clock Outflow

10 in. Circular Gravity Sewer
Pipe Out @ 12 O'Clock

Pipe Material: **Clay** ☐ Pipe Lined

Invert Depth: **18.50** (ft.) Flow Characteristics: **Slow**

Deposits: ☒ None ☐ Mud ☐ Sludge ☐ Debris ☐ Grease

Infiltration: **None** Pipe Seal Cond: **Unknown**

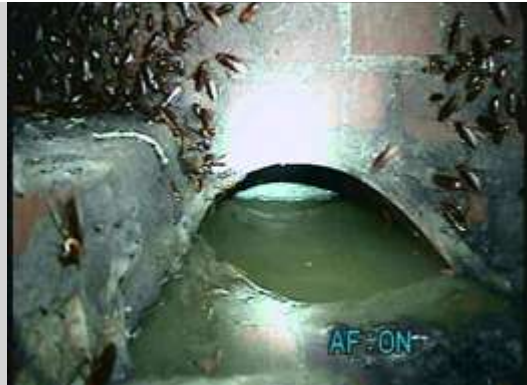
6 O'Clock Inflow

10 in. Circular Gravity Sewer
Pipe In @ 6 O'Clock

Pipe Material: **Clay** ☐ Pipe Lined

Infiltration: **None** Pipe Seal Cond: **Unknown**
